Oxidizer Shutdown Root Cause Analysis Memorandum (September 18, 1994)

Re: *Thermal Oxidizer – Summary of Root Cause Analysis*

SRNE SUPERFUND SITE
PIPING & INSTRUMENTATION DIAGRAM
LIQUID TREATMENT SYSTEM

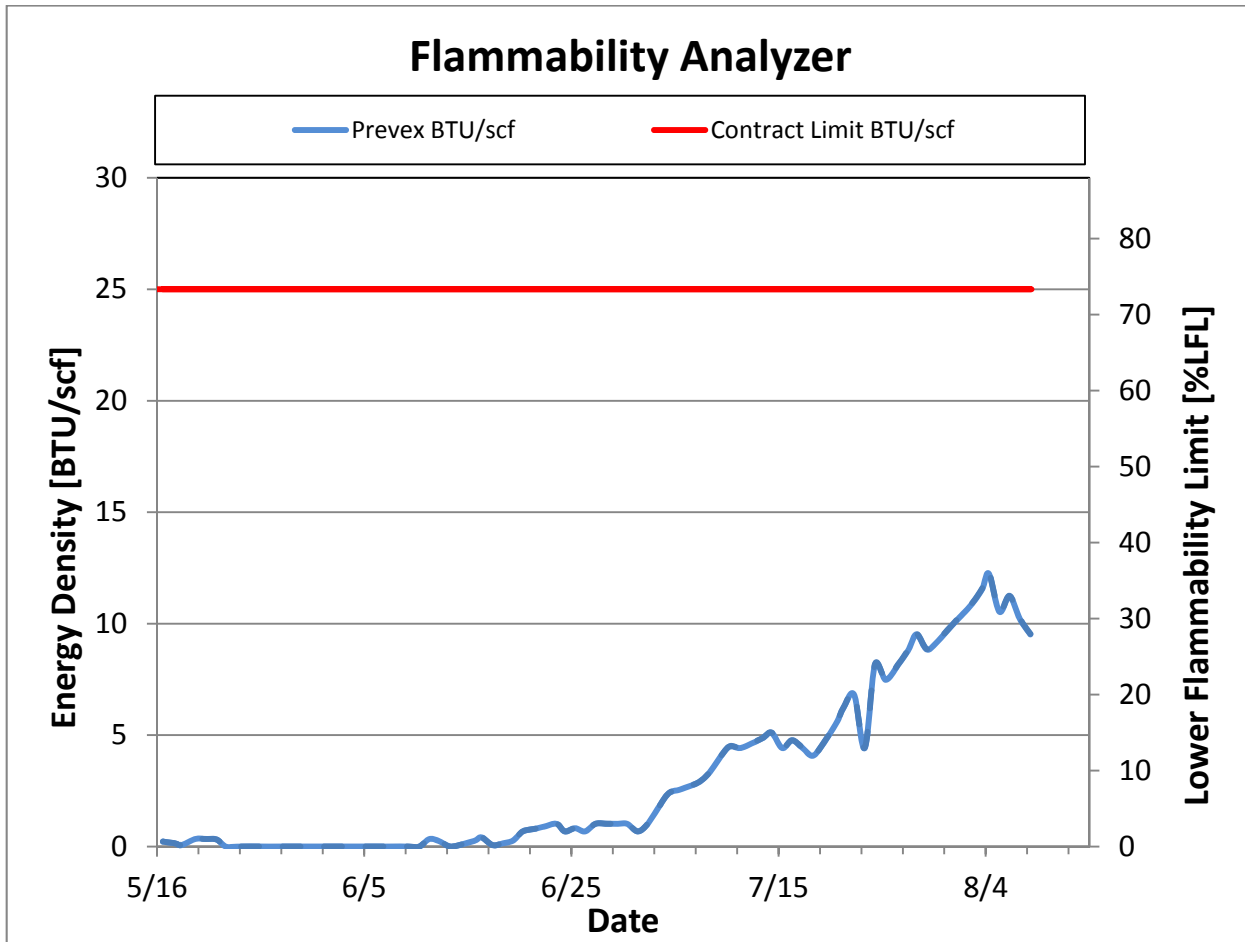
Figure 1 - Daily Average of Flammability Analyzer

Figure 1 below shows the history of project LFL data. It should be noted that the logging interval for these data was set to take a snapshot of data every two hours, whereas the cycles described above were occurring approximately every 20 minutes and the spike/drop conditions were of very limited duration. Therefore, the cyclical behavior of these readings was not captured on the logged data. On 12 August at midnight, the data logging schedule was changed to record LFL data every minute. A plot of the LFL data from this point in time until the oxidizer failure is provided below in Figure 2. The average and peak LFL values measured during this time interval were 23% and 43%, respectively.

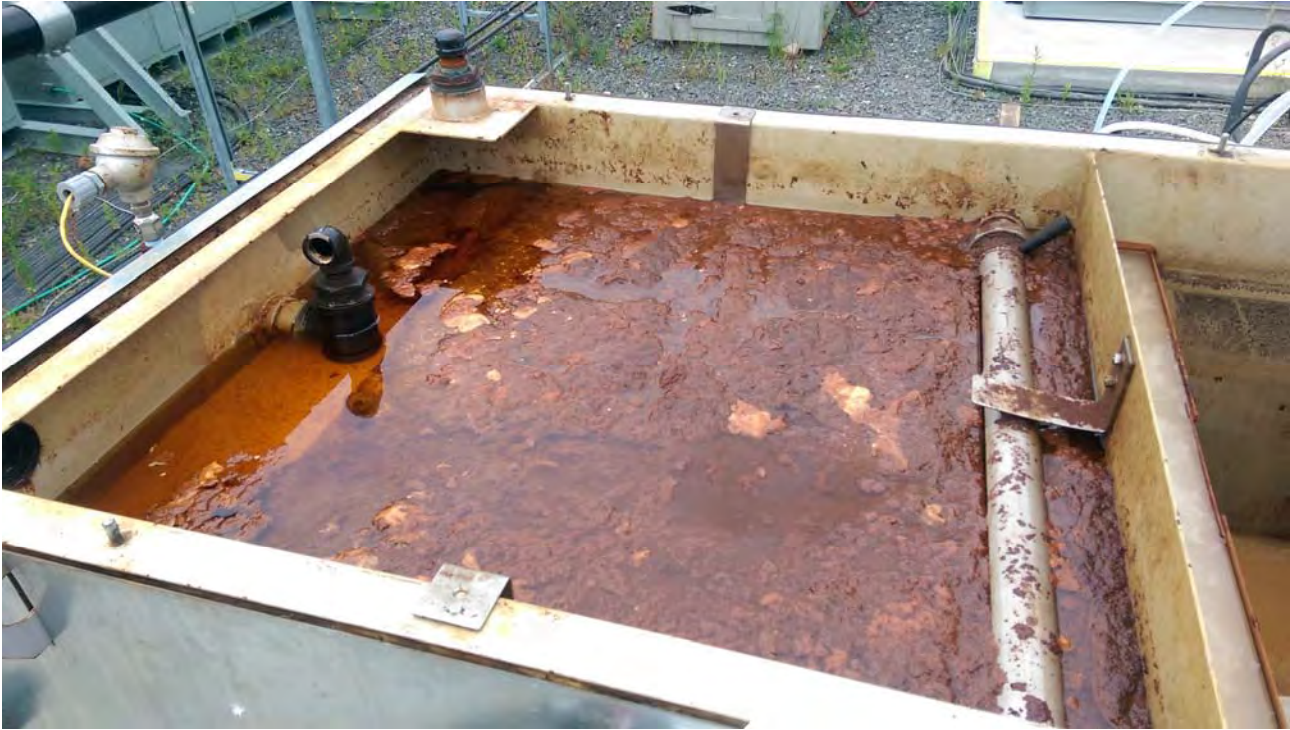
Photo of OWS Emulsion

TerraTherm believed that an emulsion or droplets of free phase materials may have been passing through the OWS to the air stripper and contributing to the transient spikes observed in LFL. The OWS and air stripper were opened and inspected. From the inspection, the OWS was found to contain both emulsified materials and a significant accumulation of Light Non-Aqueous Phase Liquid (LNAPL) (see below photos), even though the material was skimmed daily by the Operators.

As a precaution, TerraTherm installed an organoclay media vessel downstream of the OWS to capture any free phase or emulsified organic material that may pass through the OWS. We also installed an additional liquid granular activated carbon vessel at the end of the process stream (just prior to discharge to the sewer) to facilitate change-out of two primary vessels at a time to better manage higher loading rates.

- CORRECTIVE ACTION: We have installed an organoclay media vessel downstream of the OWS to remove any free or emulsified oil from the OWS effluent. Once a day, the water color in the air stripper is inspected to confirm that the clay is not saturated. Spare clay is onsite. The mist eliminator in the air stripper was inspected, cleaned, and put back into service.

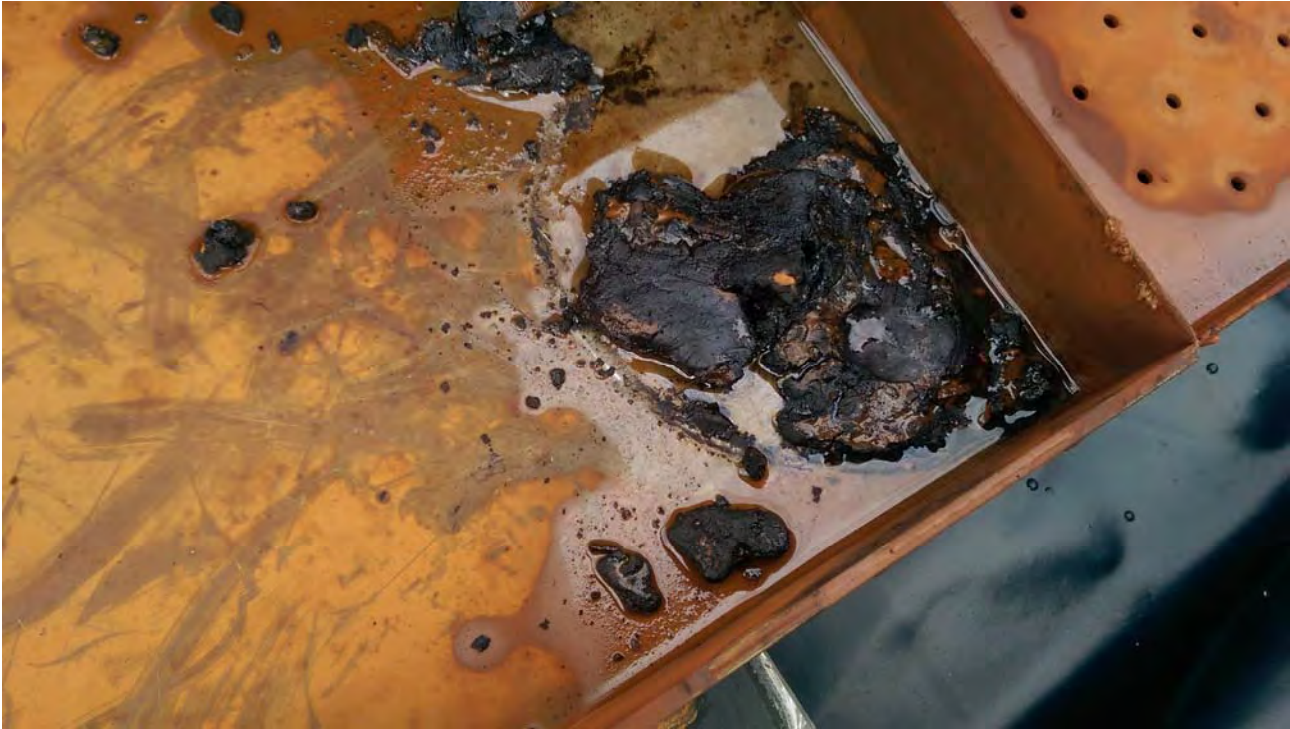
Photo of Glob of “Black Tar” in Air Stripper

The air stripper trays were found clean other than a glob of “black tar” (as shown below). A sample of the material was collected for analysis. However, once dried, it was no longer a liquid and the laboratory was not able to perform analysis on it due to insufficient volume. We have not seen this black tar material in the process stream since. It is possible that NAPL carryover or emulsified organic material occurred in the OWS and was conveyed to the air stripper, creating brief spikes in oily mist or elevated vapor phase concentrations. Based on the sampling methodology for the LFL devices, the presence of an oily mist may not be detected by the LFL sensor.

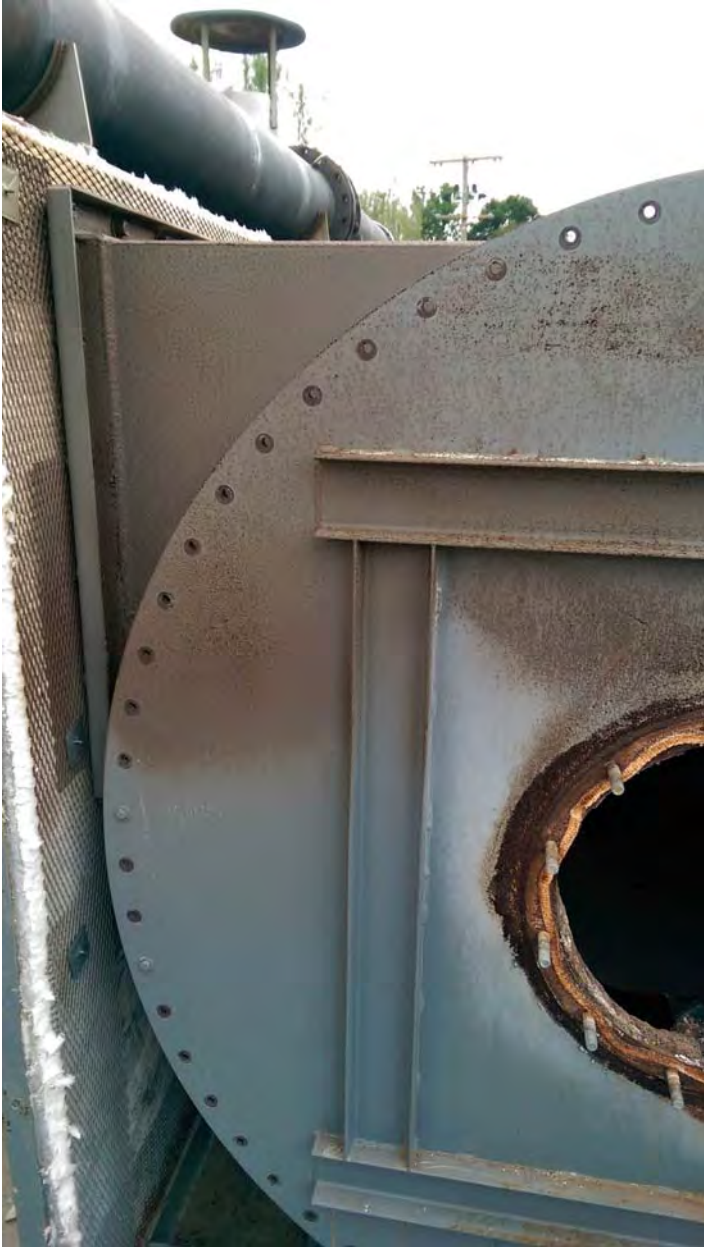
- In the photo below, the process vapor inlet is from the left, and the burner flange is in the center. Note the shell discoloration is most likely from overheating. Combustion is designed to start ~3 ft away from this end plate, and there is evidence that pre-combustion was occurring upstream of the daisy wheel.

- CONCLUSION #3: We suspect that pre-combustion was occurring not only inside the heat exchanger when it was online, but may also have occurred in the inlet chamber of the oxidizer. This suspicion is based on visual observations of the inlet plenum where localized overheating appeared to have cause discoloration and deterioration of insulated surfaces inside this chamber. However, we cannot confirm this based on available operating data.

- CORRECTIVE ACTION: We have installed a new thermocouple sensor at the inlet to the oxidizer chamber and have programmed a high temperature shutdown alarm based on this device.

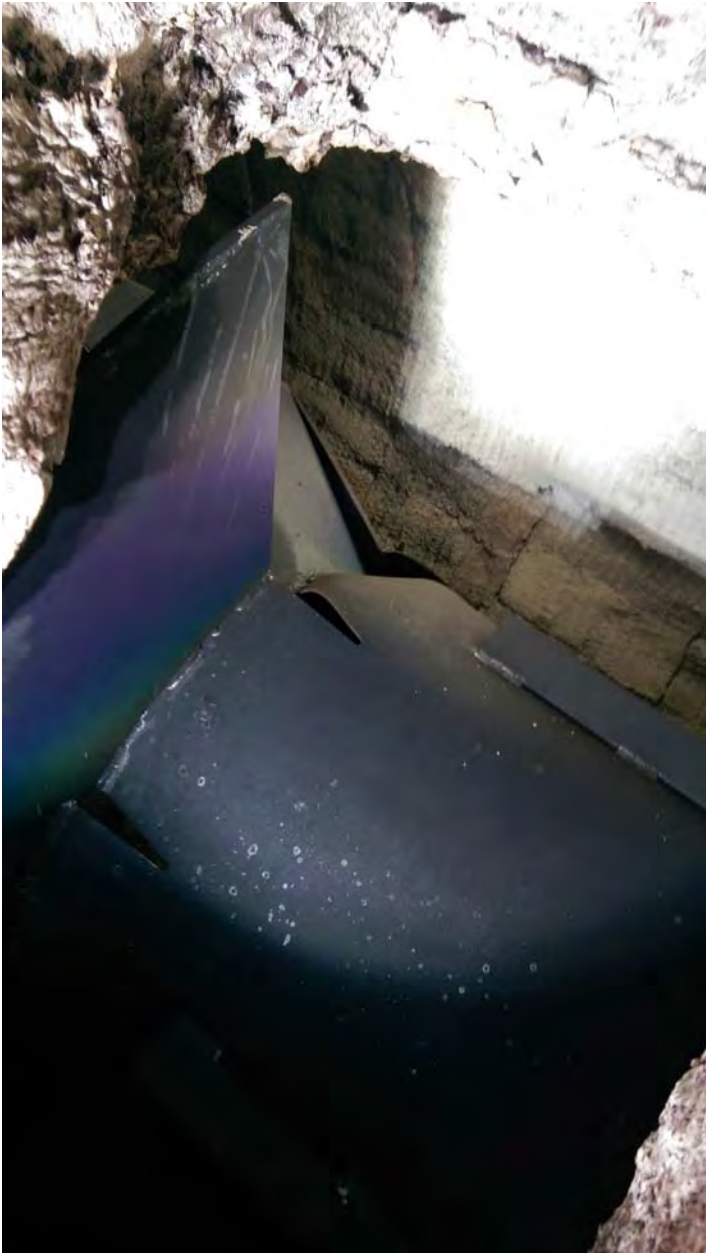
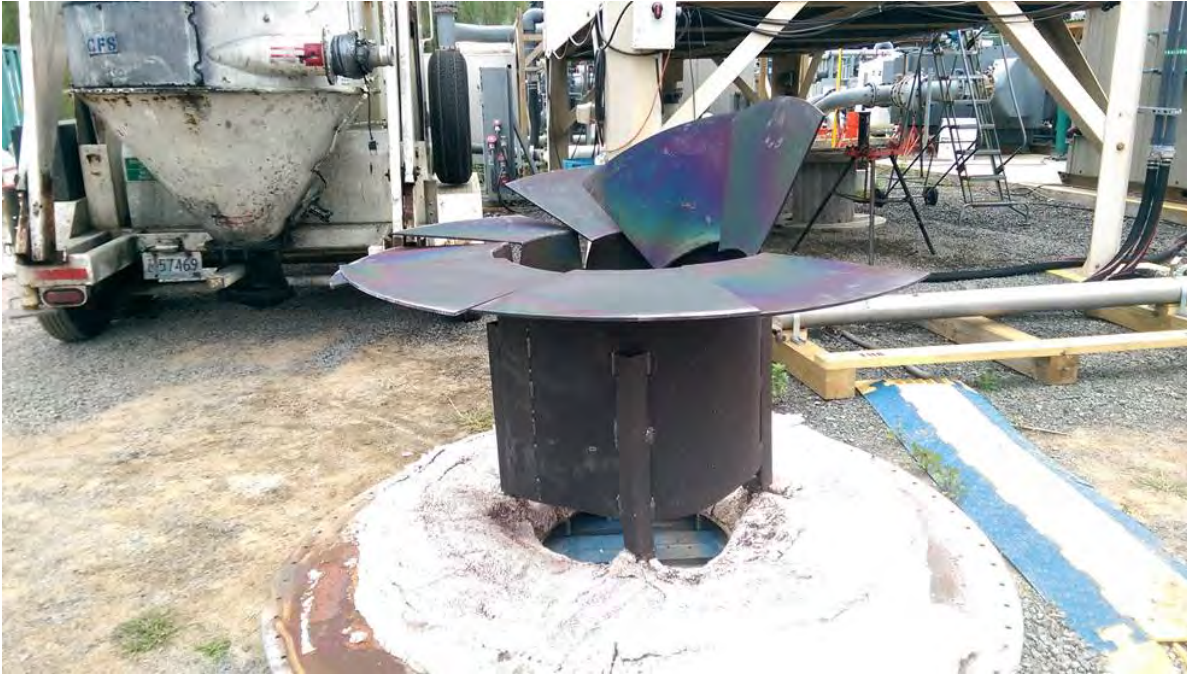
- The photo below shows the daisy wheel process flow distributor mounted on the end plate. The bent “petals” were oriented between 11:00 and 3:00 positions when viewed from the burner end plate. The impacted petals were discolored, further suggesting localized over-heating from influent vapors. A new daisy wheel assembly was designed, fabricated, and installed after this unit was removed for inspection. The replacement unit included a reinforcing ring welded to the petals of the wheel to minimize the chance of the assembly becoming distorted again due to high influent operating temperatures.

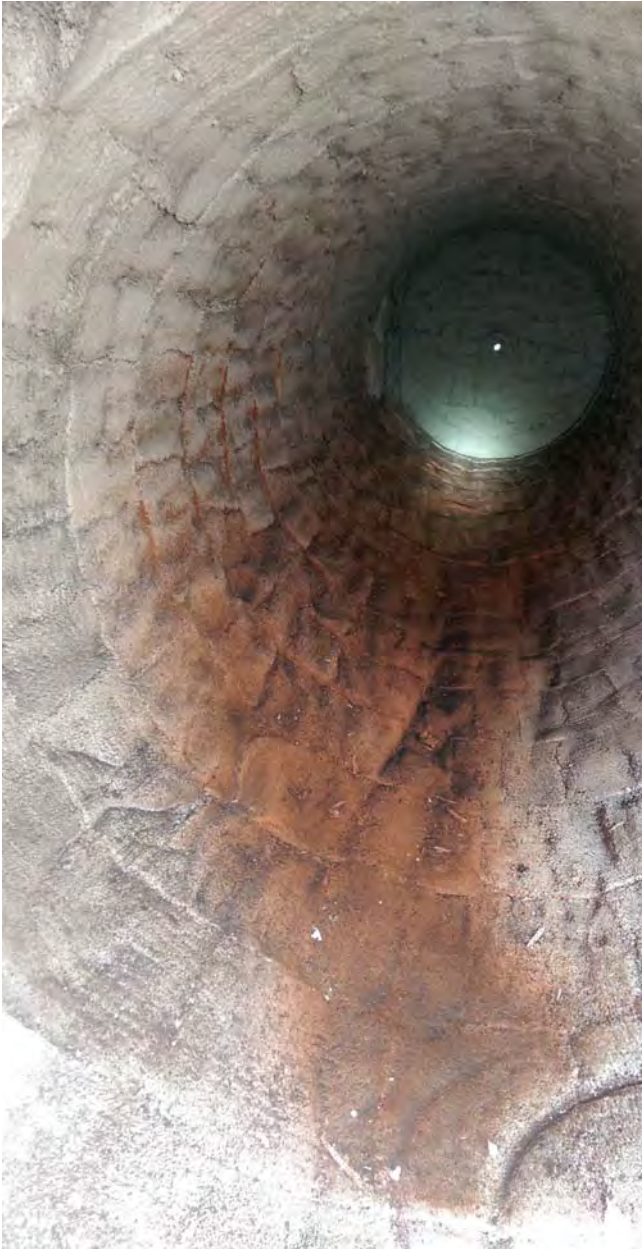
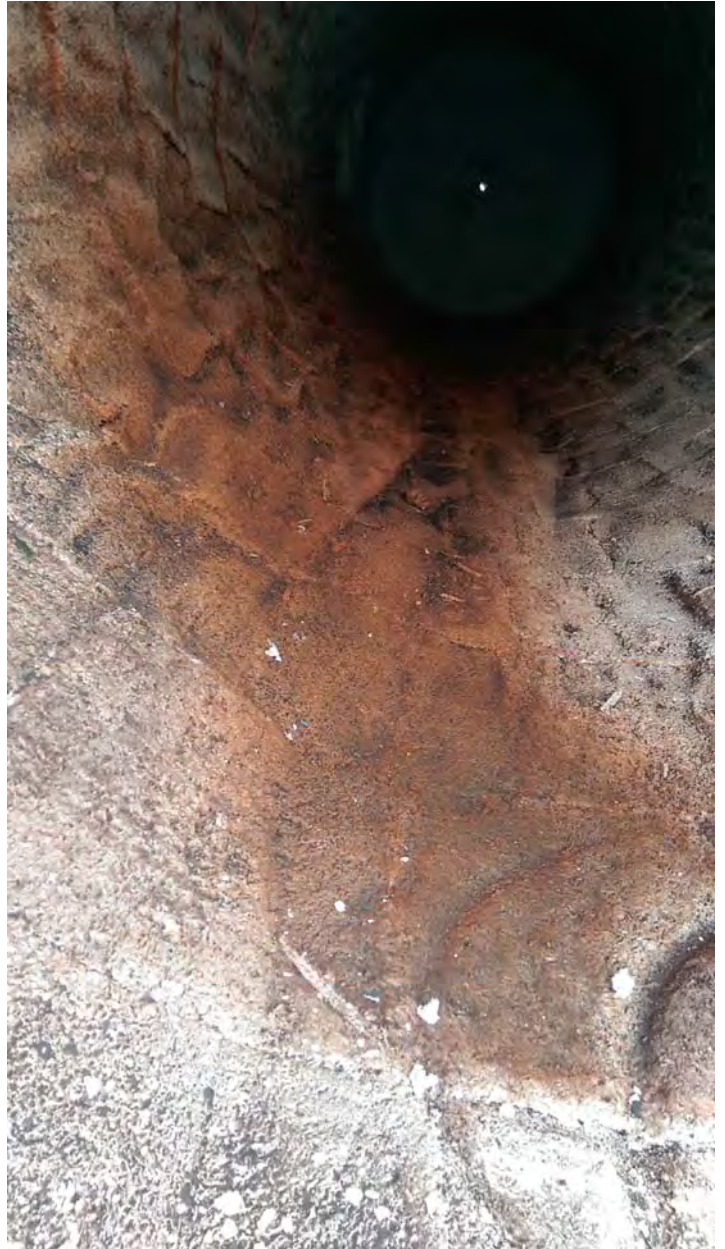
- In the photos below, the combustion chamber & roof show discoloration, likely due to impingement from a re-directed burner flame from the distorted shape of the daisy wheel.

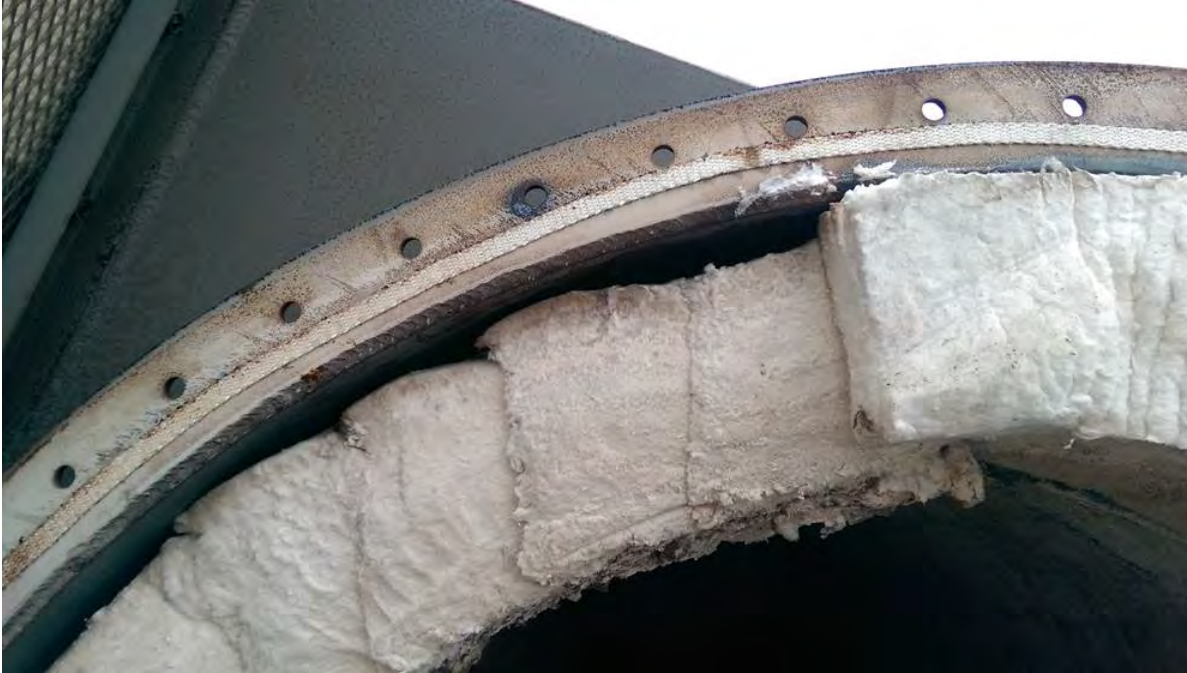
- In the photo below, refractory has separated from the combustion chamber wall at the process inlet location, presumably due to localized over-heating.

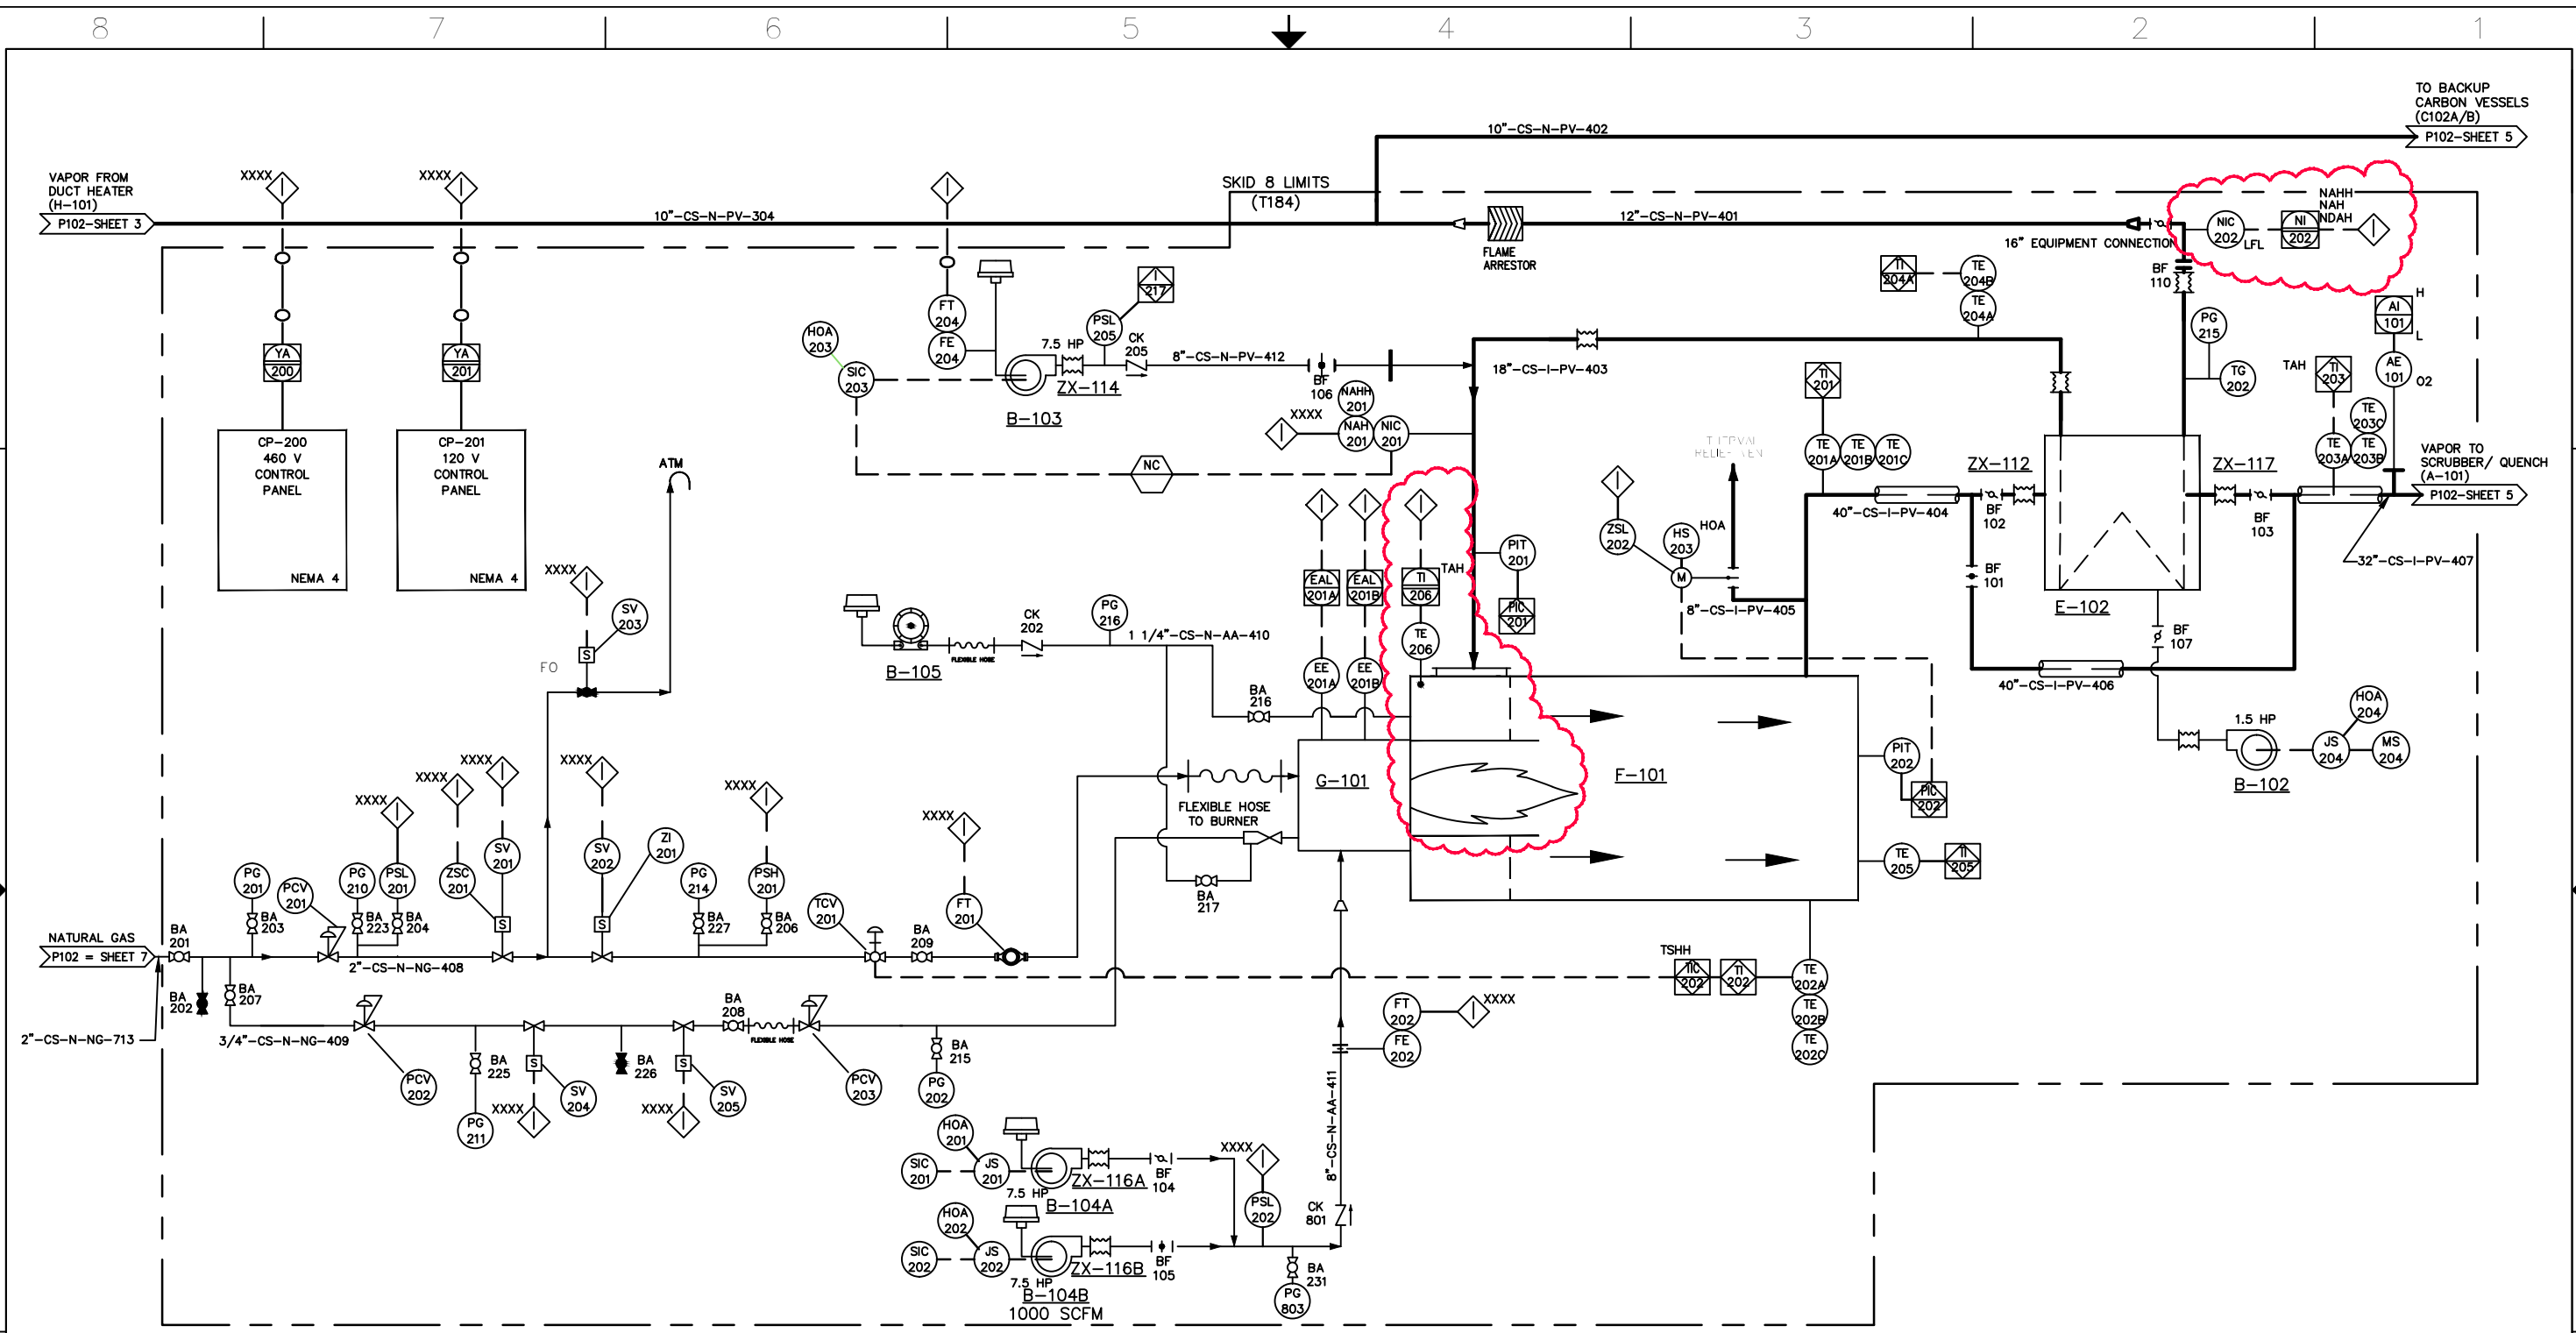
SRNE SUPERFUND SITE
 PIPING & INSTRUMENTATION DIAGRAM
 THERMAL OXIDIZER

As a result of these changes, the combustion blower increased flows from approximately 250 scfm to approximately 500 scfm, and the natural gas flow increased from approximately 20 scfm to approximately 40 scfm. With the stream not being pre-heated, and the increase in added dilution air flow, these increases in fuel usage and combustion air flow were expected. These operations are depicted in Sheet 4 of the selected Piping and Instrumentation Diagram (P&ID) in Attachment A.

- An organoclay filter was added between the OWS and the air stripper to remove free or emulsified oil, and to reduce or eliminate any transient spikes in vapor concentrations related to fluid transfers between these two operations.
- A redundant LFL sensor was installed upstream of the heat exchanger and upstream of the dilution air blower. Like the primary unit, this device is programmed to alert operators with a warning alarm when 40% LFL is reached, and a shutdown alarm at 50%.

- The primary LFL sensor will continue to control the dilution air blower operation. The blower will idle whenever LFL levels are below 40%, and will speed up as LFL rise above this level.
- A temperature sensor was installed upstream of the daisy wheel to ensure that the inlet chamber temperatures remain close to the inlet process temperature. A shutdown Alarm is currently programmed to shut down operations if temperatures increase above 500°F in the inlet chamber to the oxidizer. Currently, the temperature of the process vapor as it enters the inlet plenum is approximately 220°F.
