Oxidizer Shutdown Root Cause Analysis Memorandum (September 18, 1994)

Re: *Thermal Oxidizer – Summary of Root Cause Analysis*

SRNE SUPERFUND SITE
PIPING & INSTRUMENTATION DIAGRAM
LIQUID TREATMENT SYSTEM

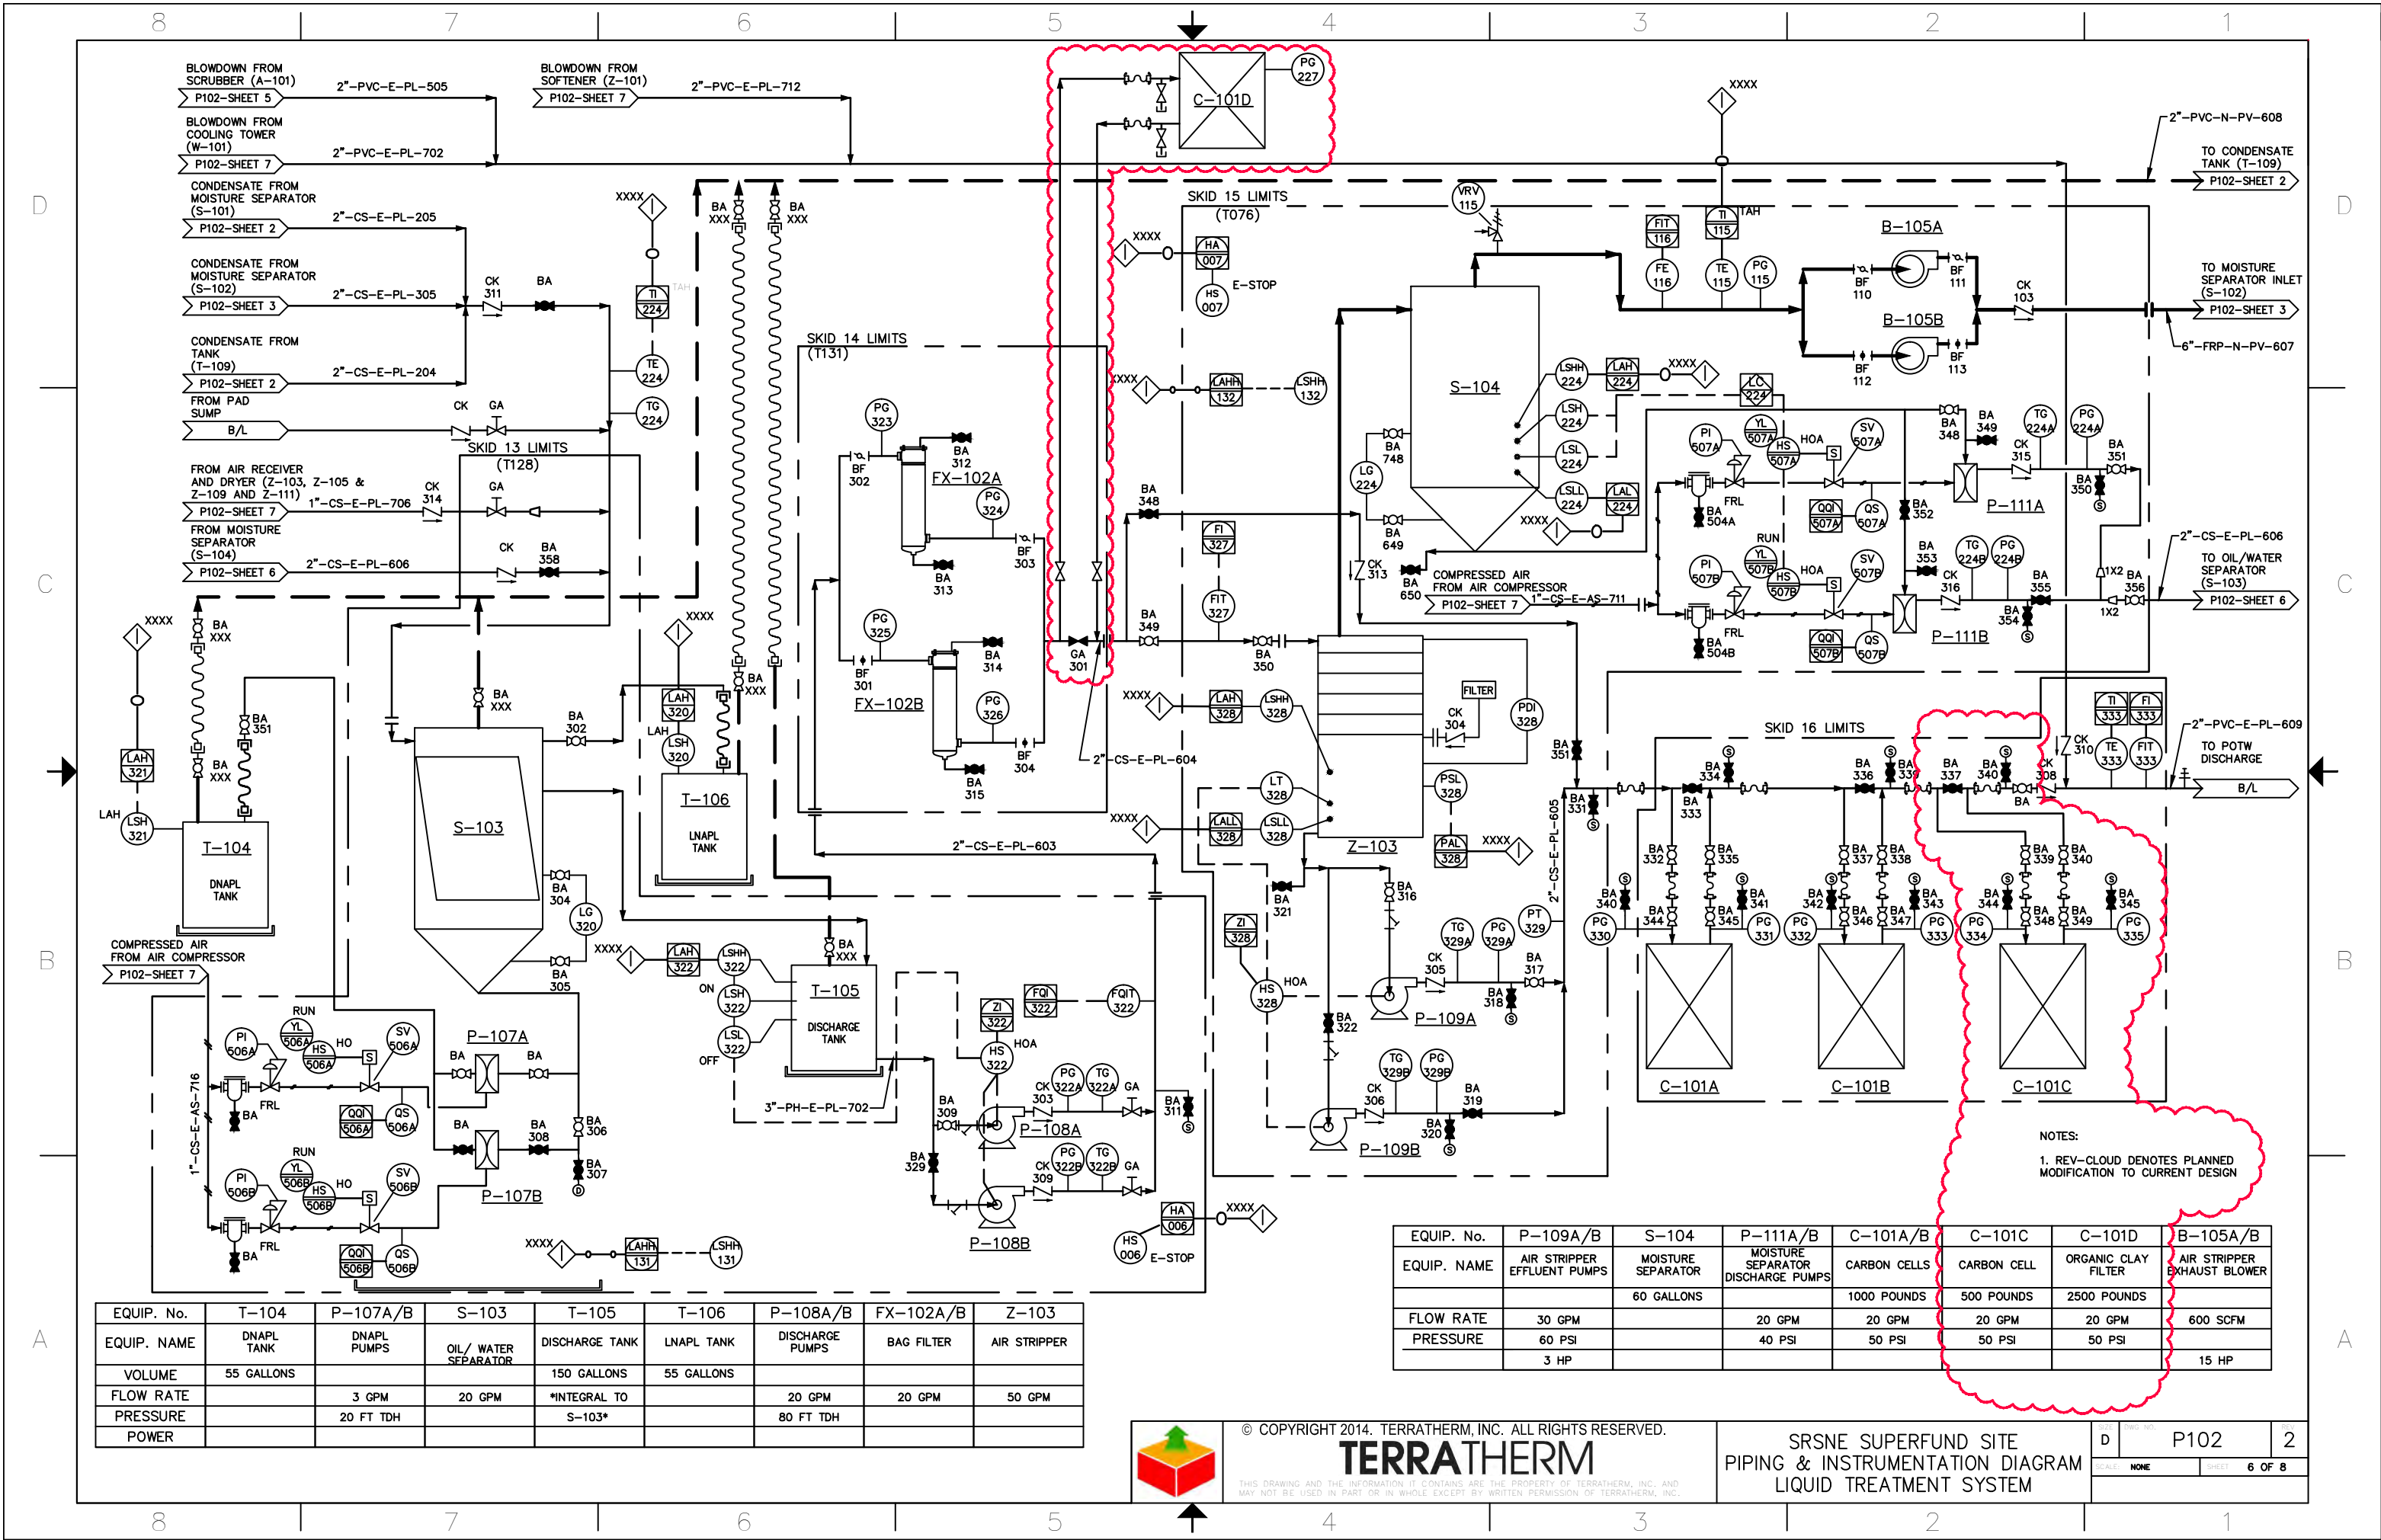
Select P&ID Sheets Illustrating System Modifications

As a result of these changes, the combustion blower increased flows from approximately 250 scfm to approximately 500 scfm, and the natural gas flow increased from approximately 20 scfm to approximately 40 scfm. With the stream not being pre-heated, and the increase in added dilution air flow, these increases in fuel usage and combustion air flow were expected. These operations are depicted in Sheet 4 of the selected Piping and Instrumentation Diagram (P&ID) in Attachment A.

NOTES:
1. REV-CLOUD DENOTES PLANNED MODIFICATION TO CURRENT DESIGN
